# **#PROJECT NARRATIVE**

**Village at Broad Rock**  
**AP 33 Lot 24**  
**852 Broad Rock Road**  
**South Kingstown, Rhode Island**

**September 2023** (revised 4/18/24)  
*CE&C Project No. 23011.00*

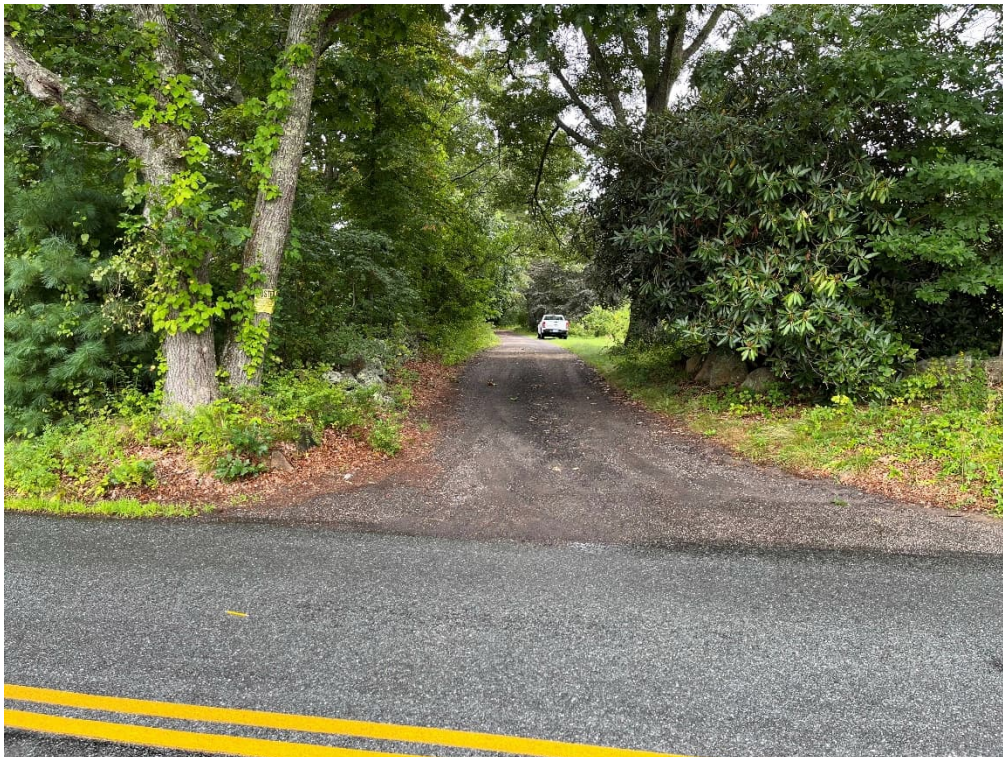
Photo above showing the view from Broad Rock Road looking into existing driveway.

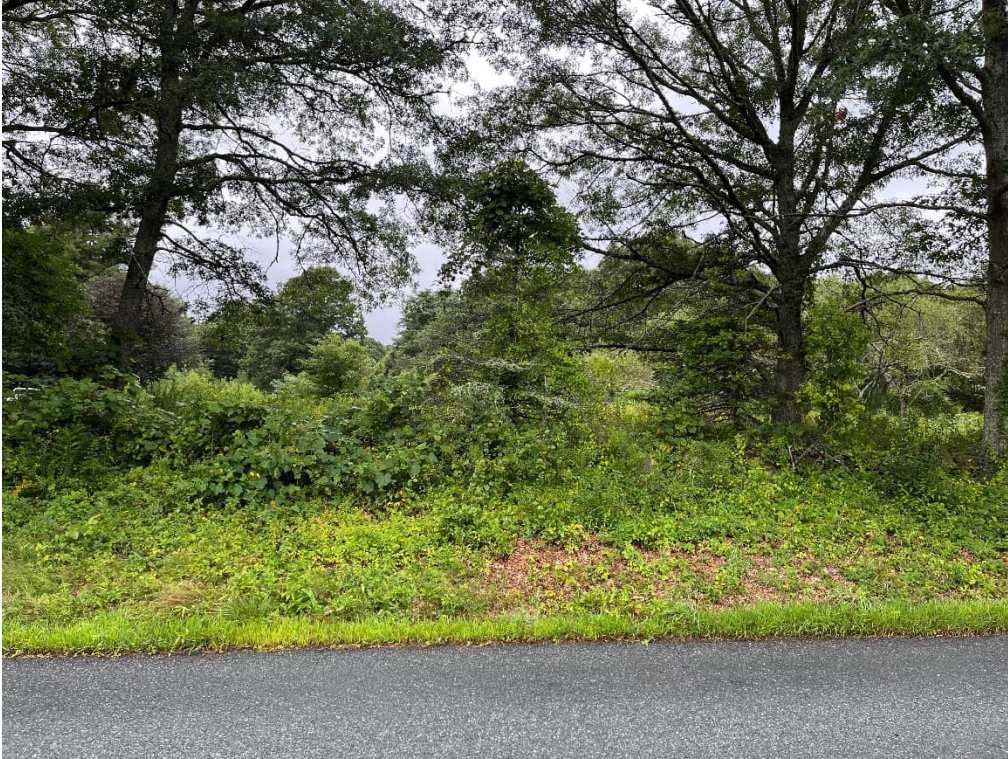
Photo above showing view from Broad Rock Road into the property near the center of the frontage.

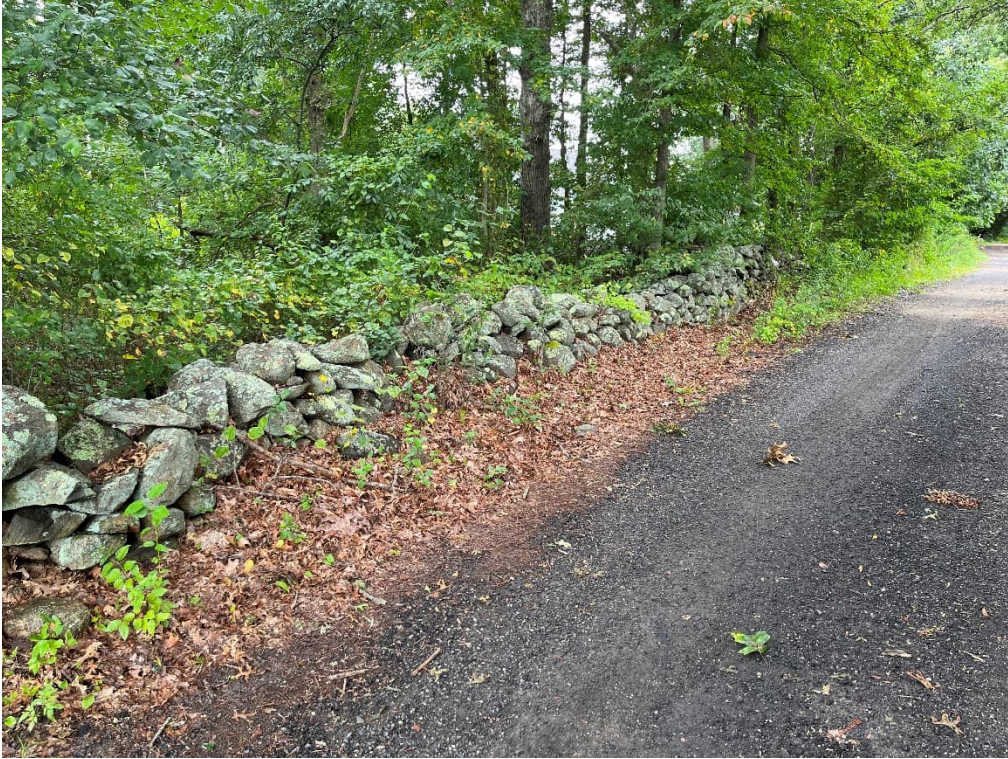
Photo above showing the stone wall and driveway along the southern property line.

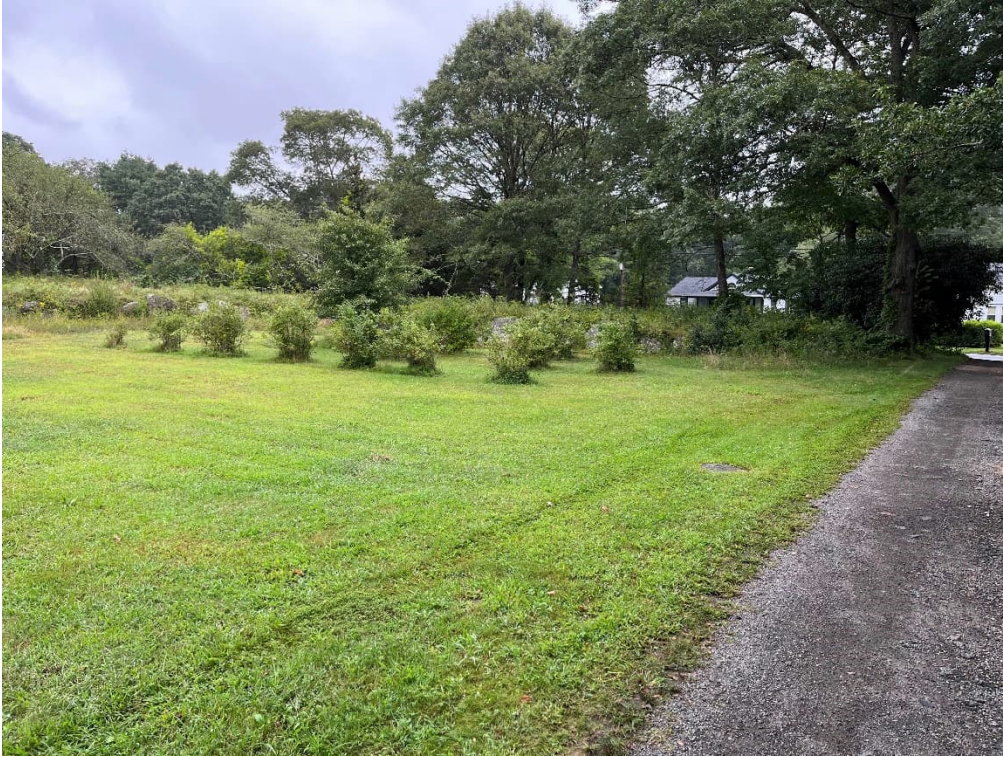
Photo above showing the front yard area with Broad Rock Road in the distance.

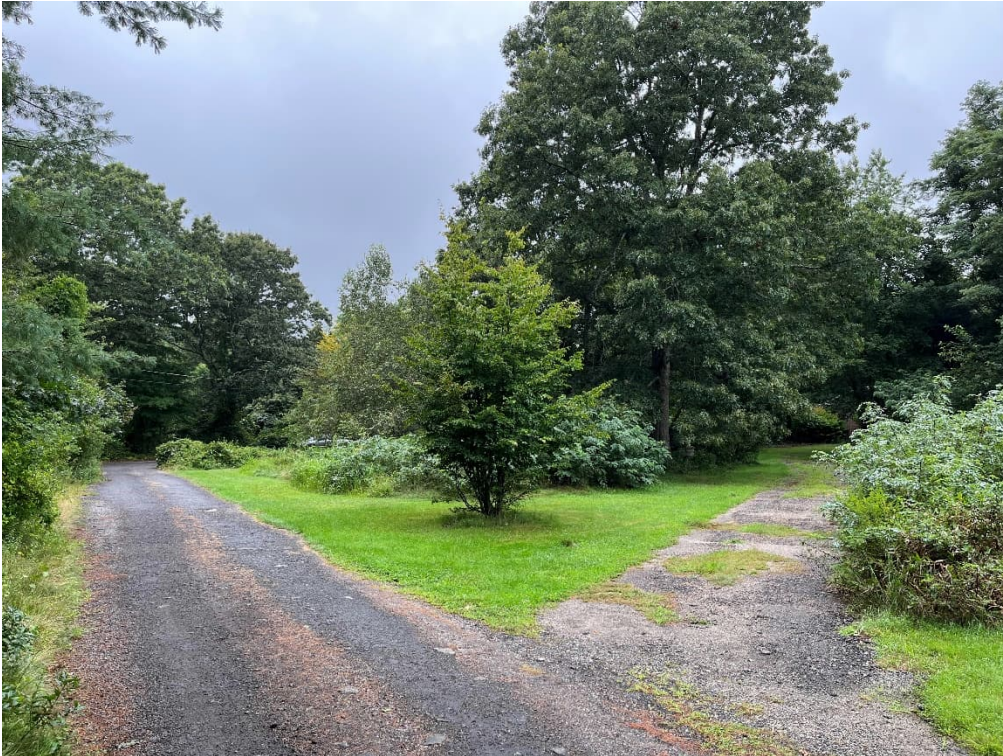
Photo above showing the driveway intersection at the start of the loop (looking west).

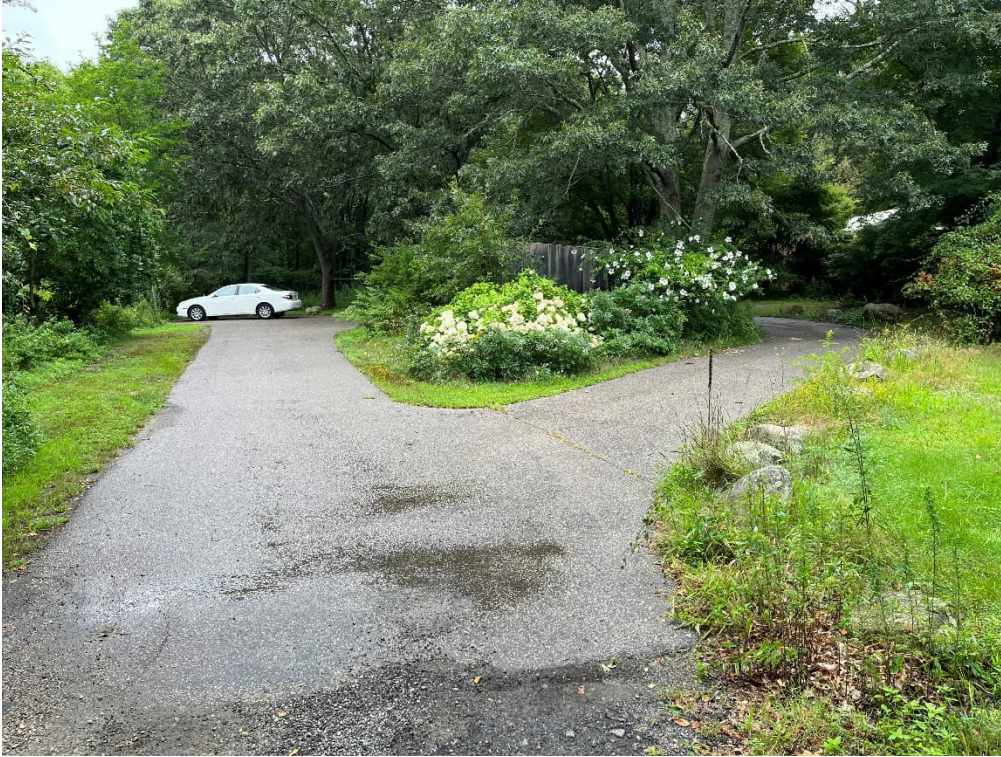
Photo above showing the driveway near the dwelling and garage at the small circle (looking north).

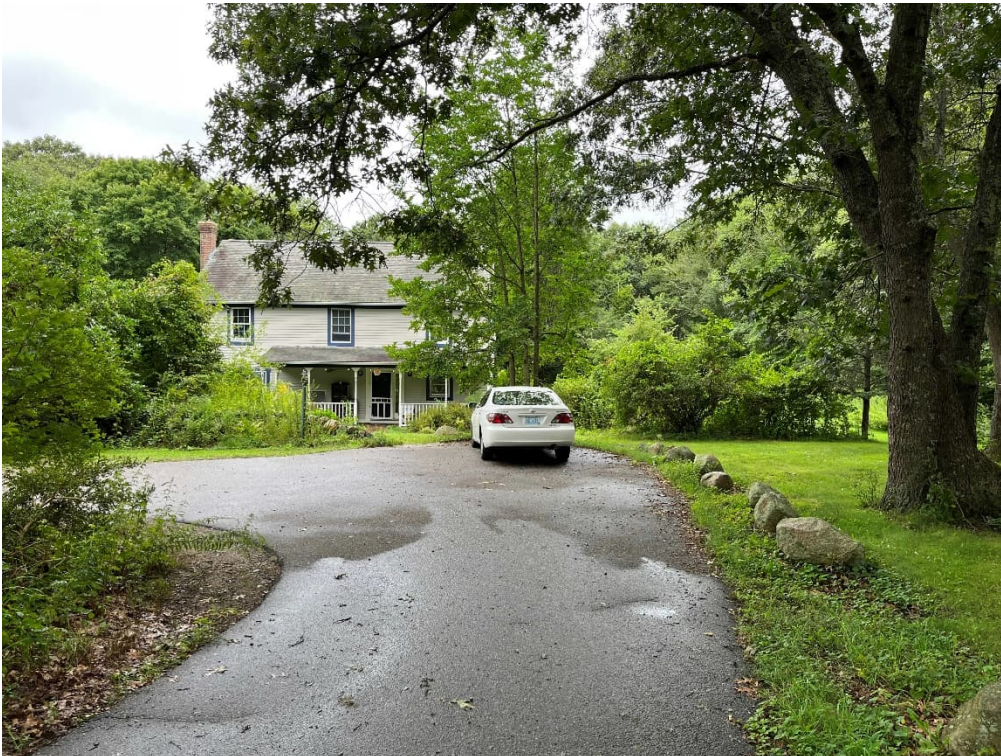
Photo above showing the existing dwelling (looking west).

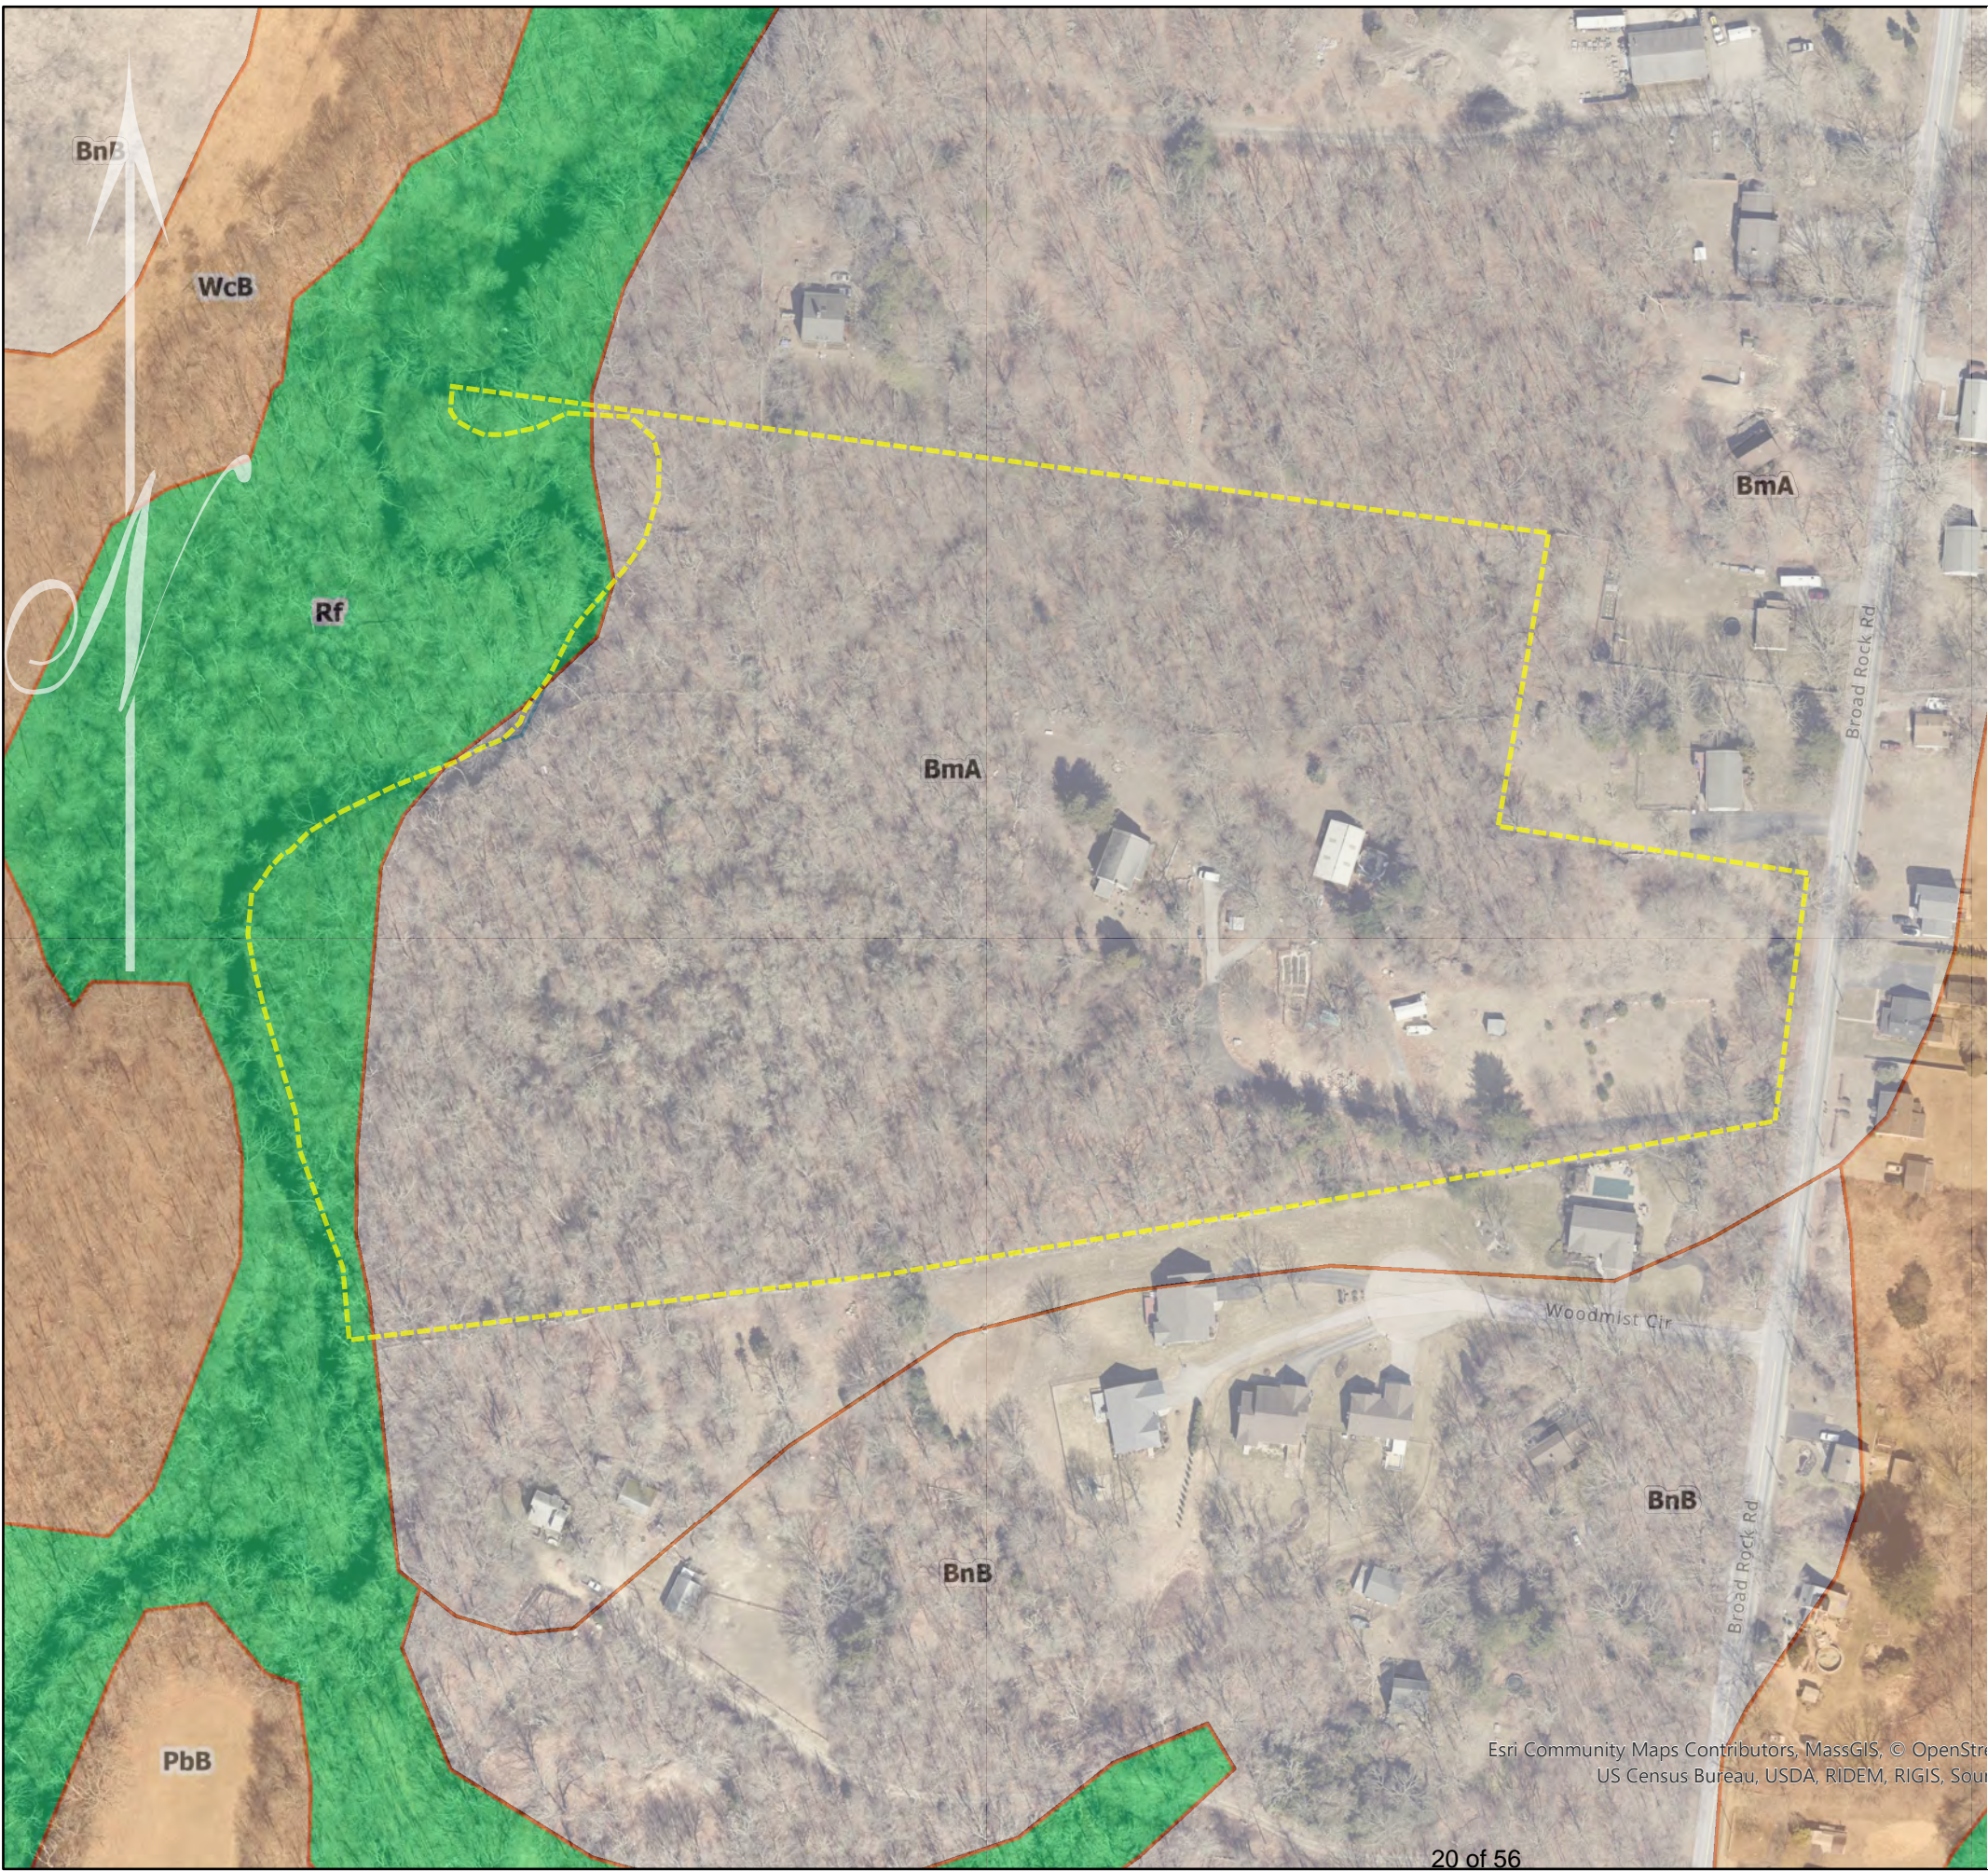
USDA - NRCS SOIL SURVEY MAP  
 A.P. 33, Lot 24 | 852 Broad Rock Road  
 South Kingstown, Rhode Island

- BmA - Bridgehampton silt loam, till substratum, 0 to 3 percent slopes
- BnB - Bridgehampton-Charlton complex, very stony, 0 to 8 percent slopes
- PbB - Paxton very stony fine sandy loam, 0 to 8 percent slopes
- Rf - Ridgebury, Whitman, and Leicester extremely stony fine sandy loams
- WcB - Wapping very stony silt loam, 0 to 8 percent slopes

**Soils:** The USDA-NRCS Soil Survey map indicates the soil in the proposed development area is BmA-Bridgehampton with typical characteristics of water tables greater than 6’ deep and bedrock greater than 5’ deep. Soil evaluations were performed by Avizinis Environmental Services, Inc. and witnessed by the RIDEM. Ground water tables were then monitored during the wet season and re-affirmed at deeper depths and verified by the RIDEM under OWTS application #2332-0114. Soil logs, location map, soils map and verified groundwater tables are provided in the Appendix.

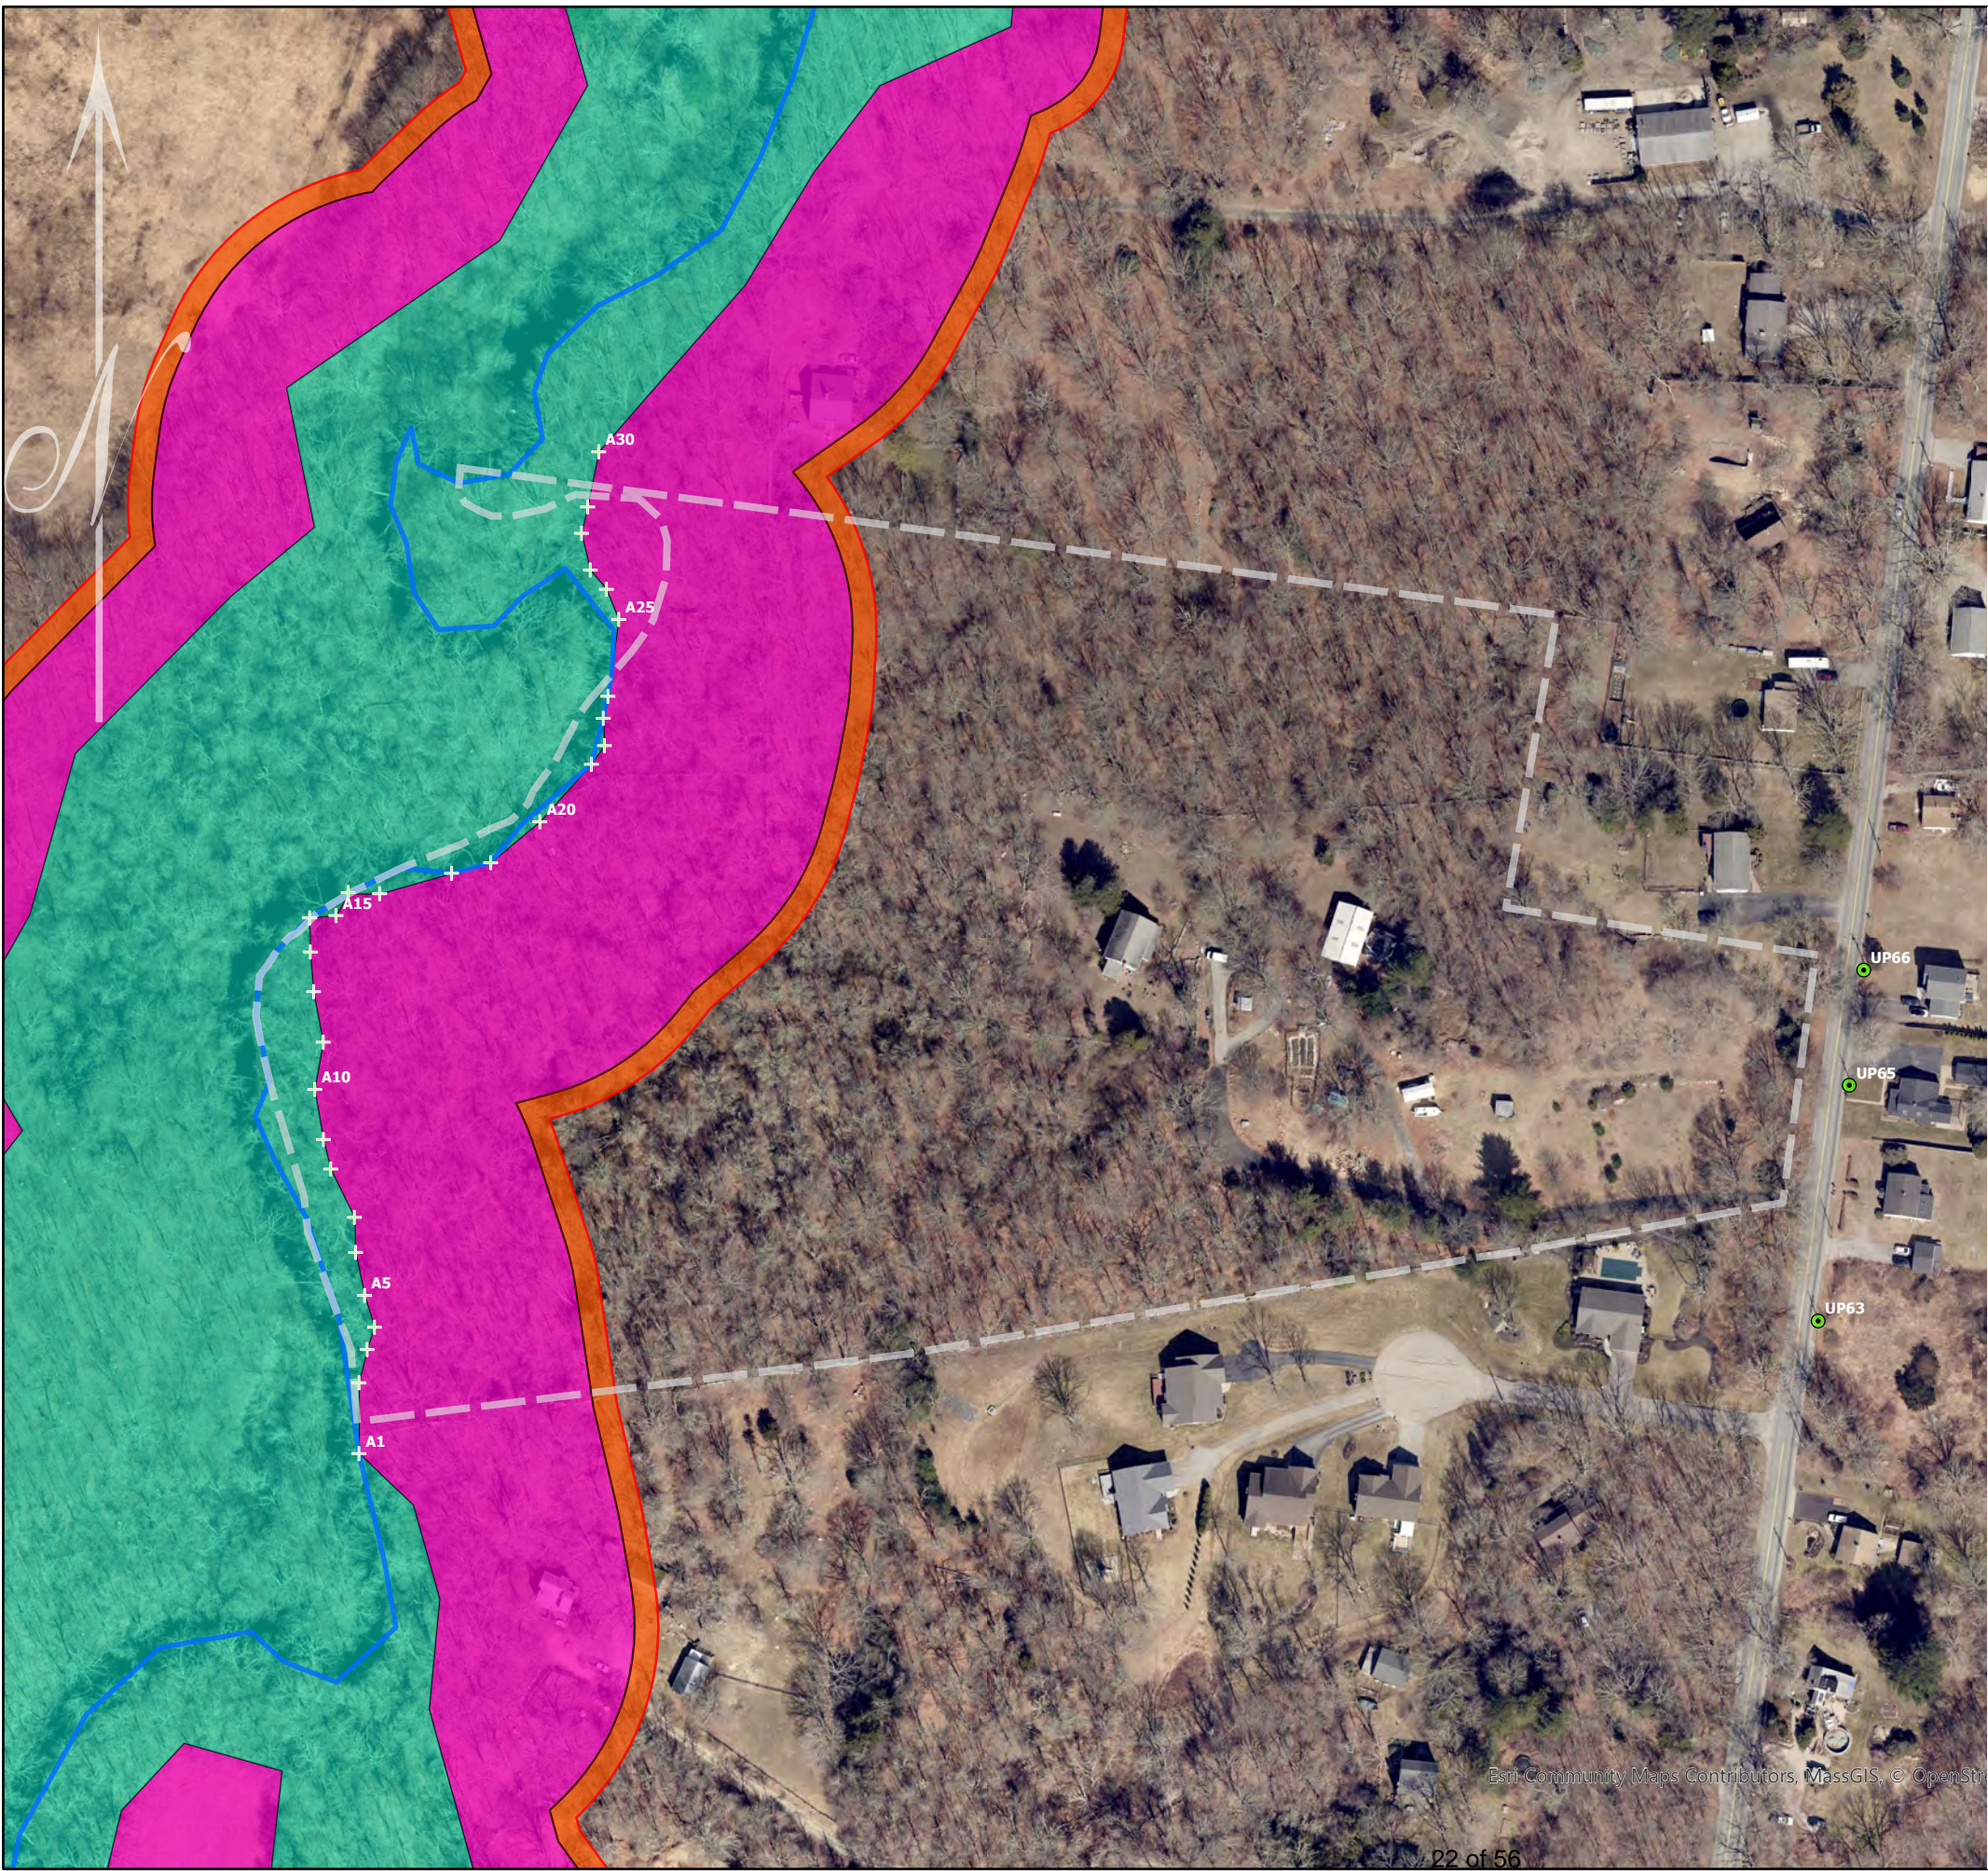
2022 WETLAND DELINEATION MAP  
 A.P. 33, Lot 24 | 852 Broad Rock Road  
 South Kingstown, Rhode Island

- PROPERTY LINE
- GPS BENCHMARK LOCATION
- AES WETLAND FLAG
- WETLAND FEATURE
- BUFFER ZONE
- CONSTRUCTION SETBACK
- RIVER

AES has established one wetland flag series on the property. Flagging labeled **A1 – A30** delineates the closest limit of a swamp surrounding Saugatucket River along the western edge of the property and extending well off the lot, following the course of the river off to the north and south.

Flag Series	Classification	Jurisdictional Area (ft)	Buffer Zone (ft)	Setback (ft)
A1 – A30	Swamp	100	75	20
Not flagged	River (Saugatucket River)	200	200	20

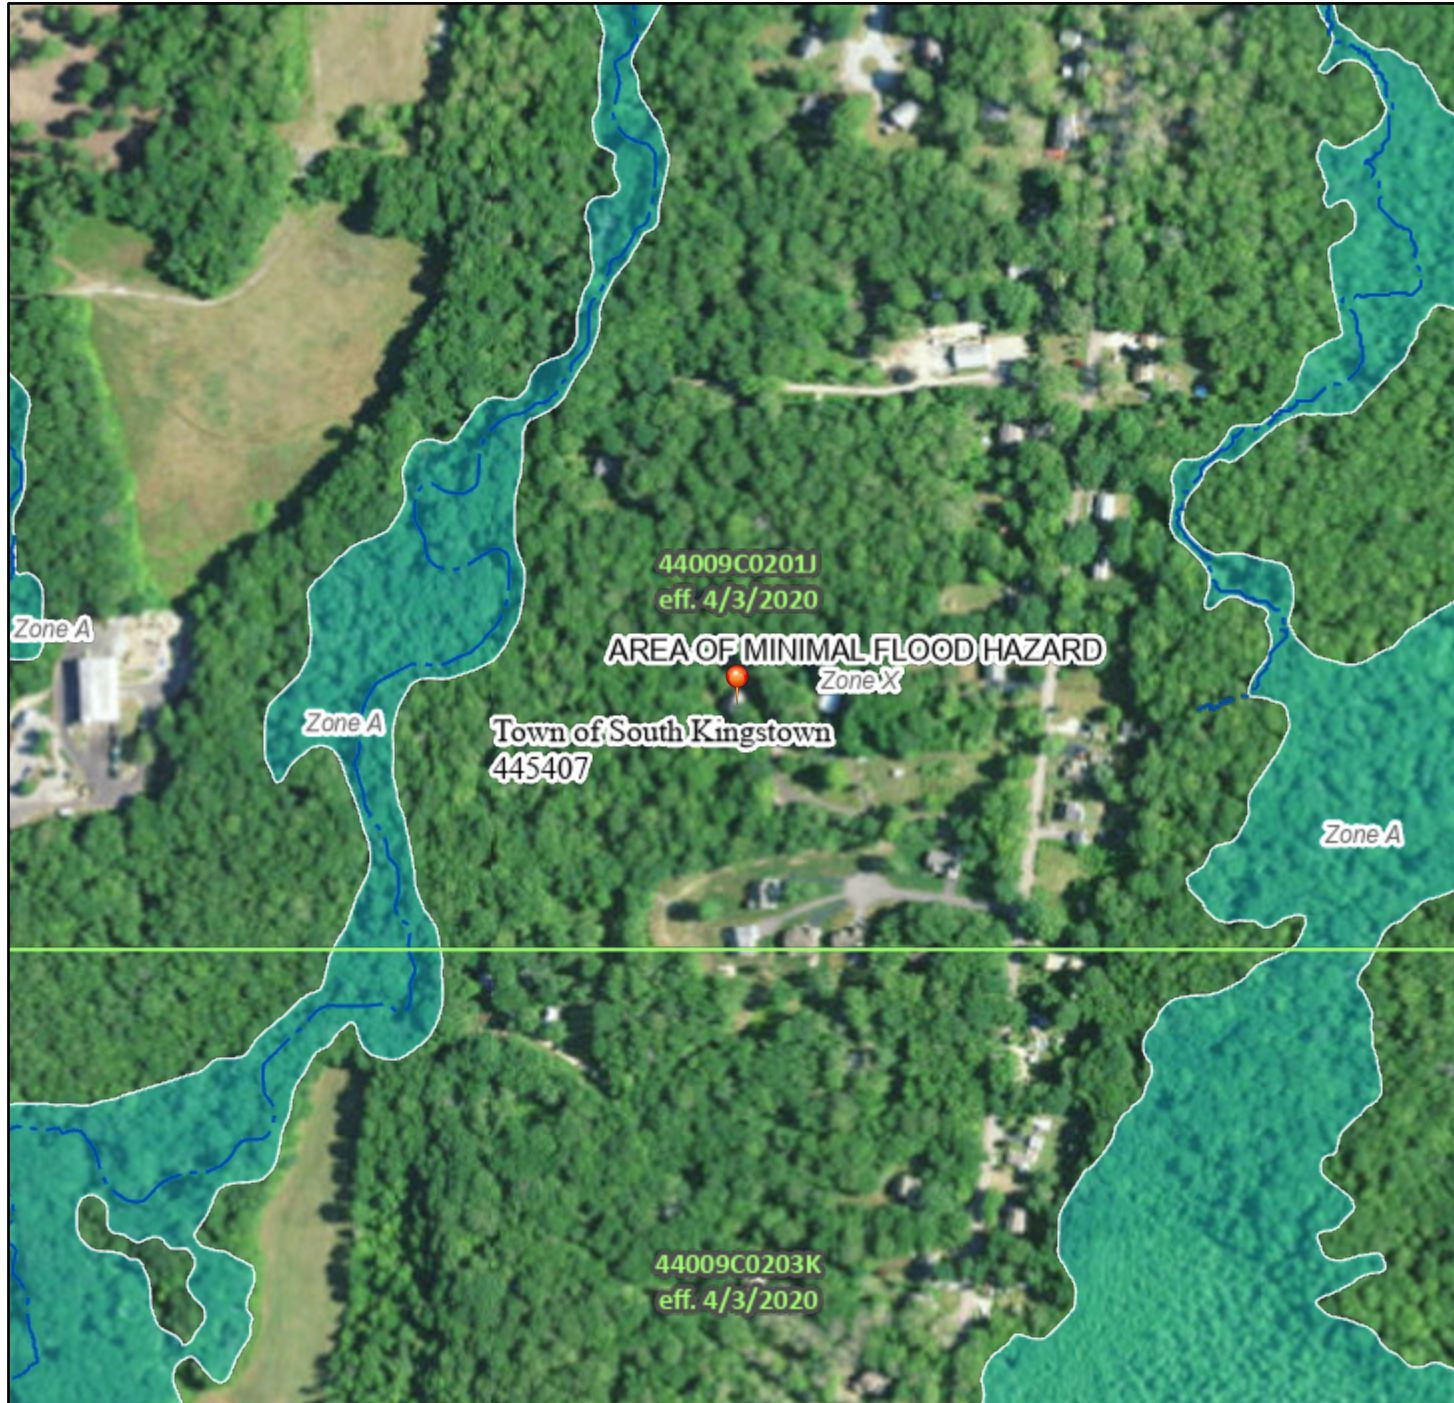
# National Flood Hazard Layer FIRMMette

The flood hazard information is derived directly from the authoritative NFHL web services provided by FEMA. This map was exported on **3/1/2023 at 11:59 AM** and does not reflect changes or amendments subsequent to this date and time. The NFHL and effective information may change or become superseded by new data over time.

**Flood Zones:** The subject property is predominately situated in Zone X 'Area of minimal flood hazard' as identified by the Federal Emergency Management Agency Flood Rate Insurance Map, #44009C0201J, effective April 3, 2020. A small, localized area around the Saugatucket River is identified as a special flood hazard area Zone A. Refer to the attached FEMA map and site plans for the location of Zone A. The Saugatucket River is situated in the Town's special flood hazard area overlay district.
